8.2.1 17th – 18th century cellar

8.2.2 17th – 18th century buildings and associated features

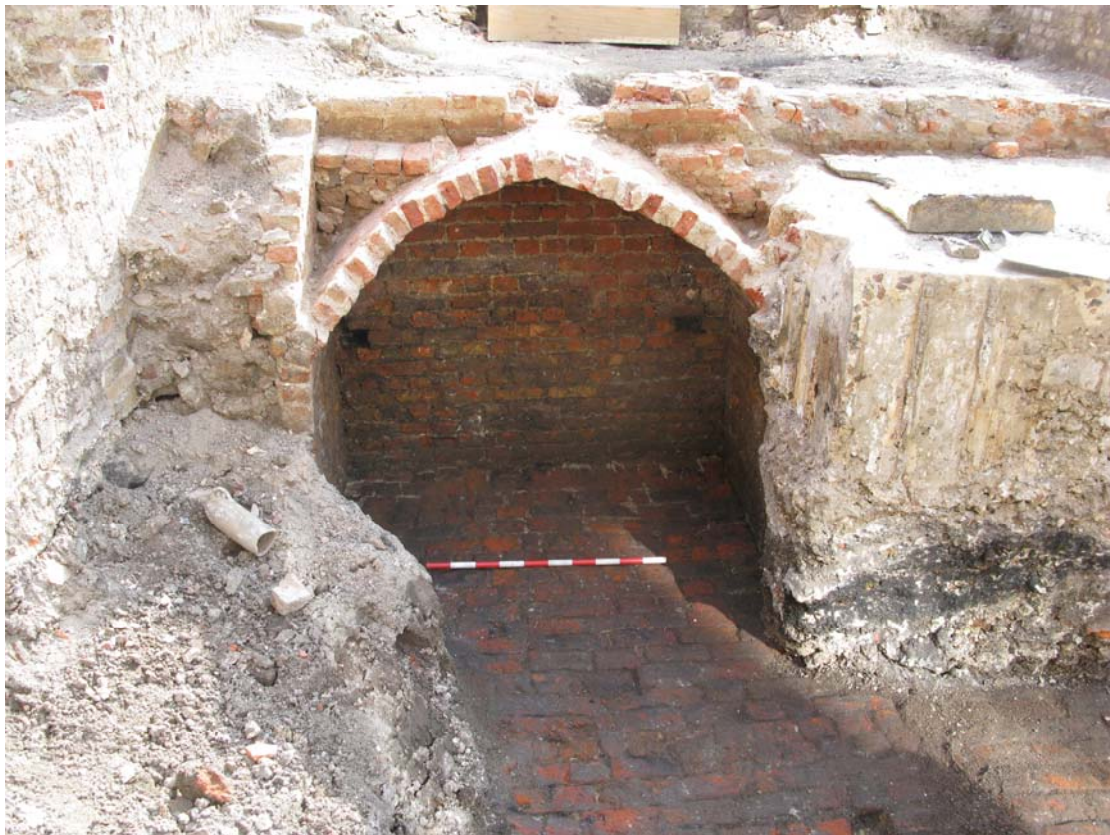
Fig 17 View of Internal arch-roofed alcove [88], looking East

Walls [107], [121] and [91] form the west, south and east walls of a 17th-18th century cellar with brick floor [133] and an internal arch-roofed alcove [88] abutting the eastern back wall [91] (Figs 17-18). The cellar shows signs of being in use through both the eighteenth and perhaps 19th centuries. An additional wall [120], which forms an internal western wall of the cellar, appears to have a recess that was bricked up at a later date with a possible 18th century wall [125]. This feature may have been for an entrance way, light well or similar. A later stairway [124] was recorded in the southern wall [121] of the cellar with the addition of a brick supporting plinth to the immediate west of this entranceway and abutting the internal face of cellar wall [121], (Fig 19). These later additions are evidence that the cellar remained in use into the 19th century.

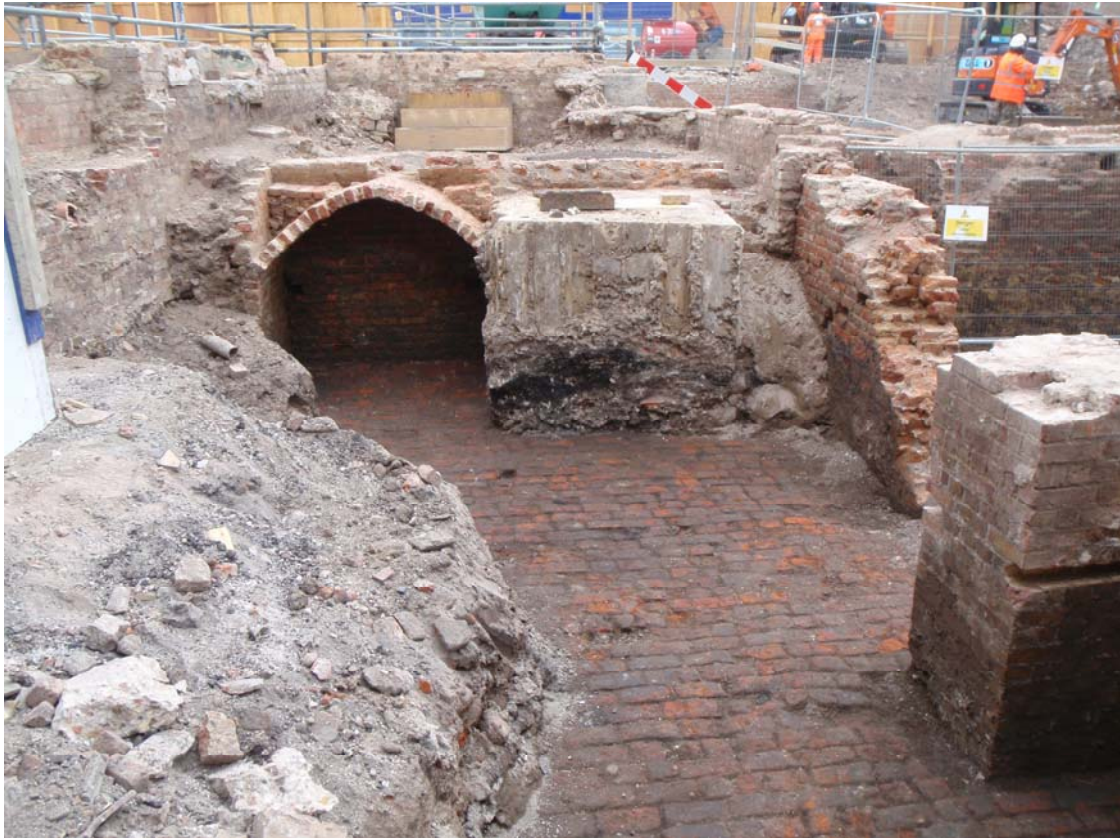
Fig 18 View of cellar floor [133], looking East

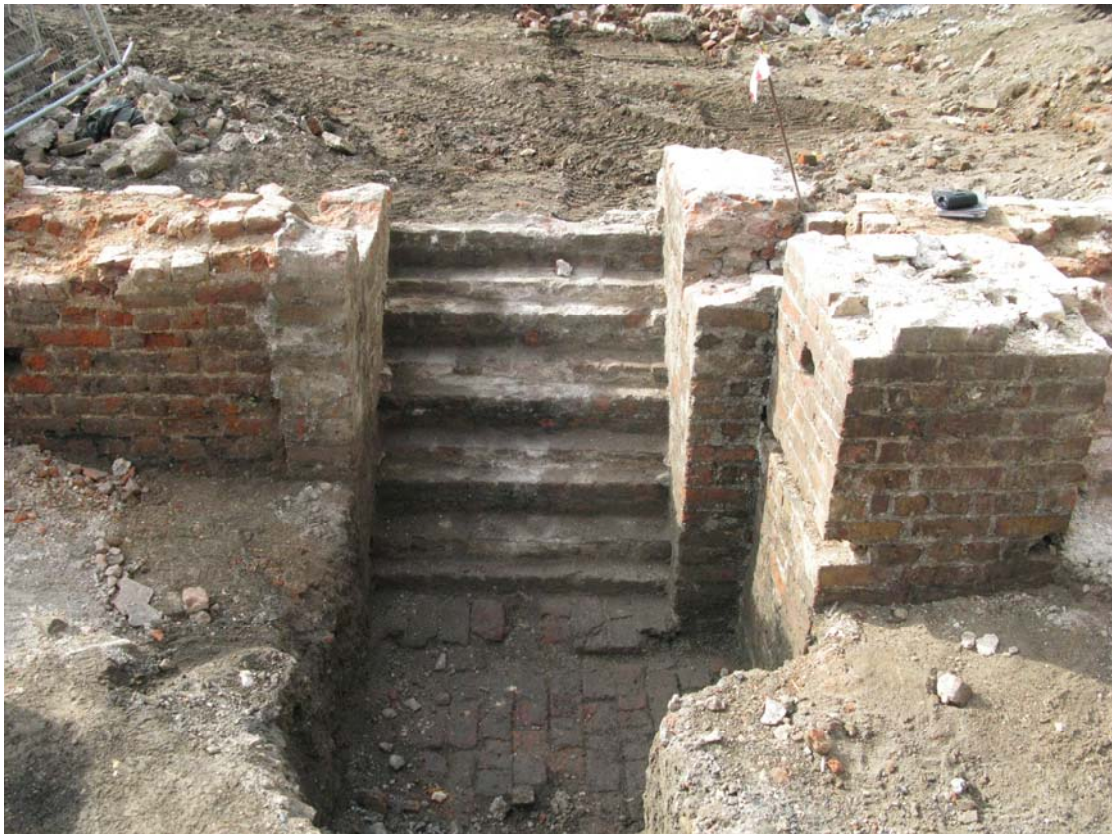
Fig 19 View of stairway addition [124], looking South

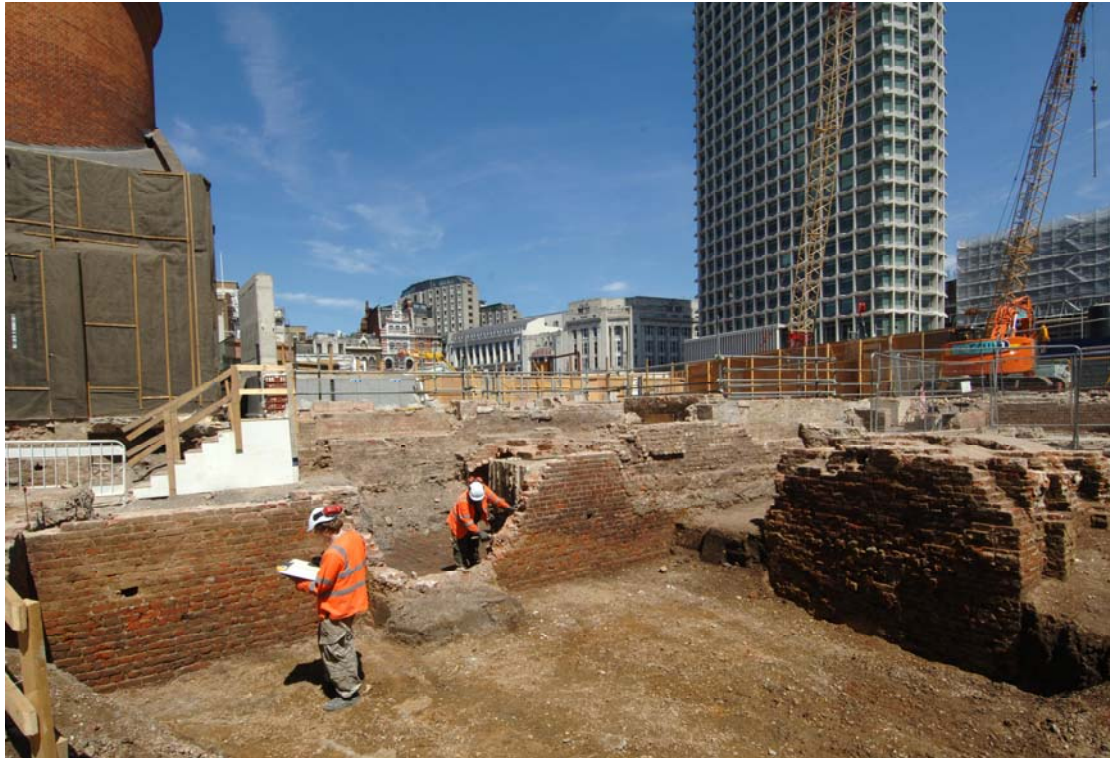
Fig 20 View of cellar wall [121] and later cistern [104], looking North-East
